ADVANCED MASTERS IN STRUCTURAL ANALYSIS
OF MONUMENTS AND HISTORICAL CONSTRUCTIONS

Master's Thesis

Inventory of Repairing and Strengthening Techniques for Masonry Arch Bridges

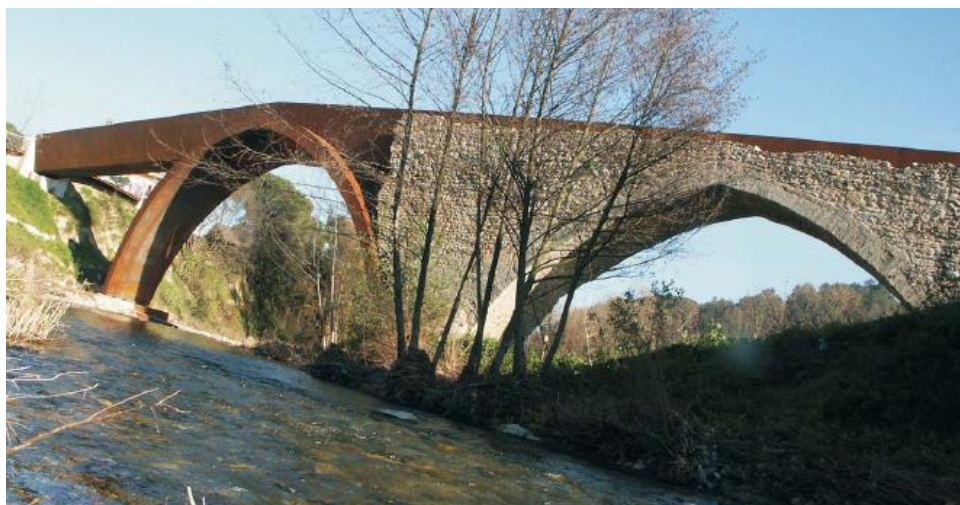
Therefore, it was determined that the better intervention would be to construct the missing part with a modern structure, connected to the older part (Figure 1.6). This results in a functional bridge that preserves the authenticity of the remaining bridge.

Figure 1.6: Completed Pont Trencat Intervention (Font, 2004).

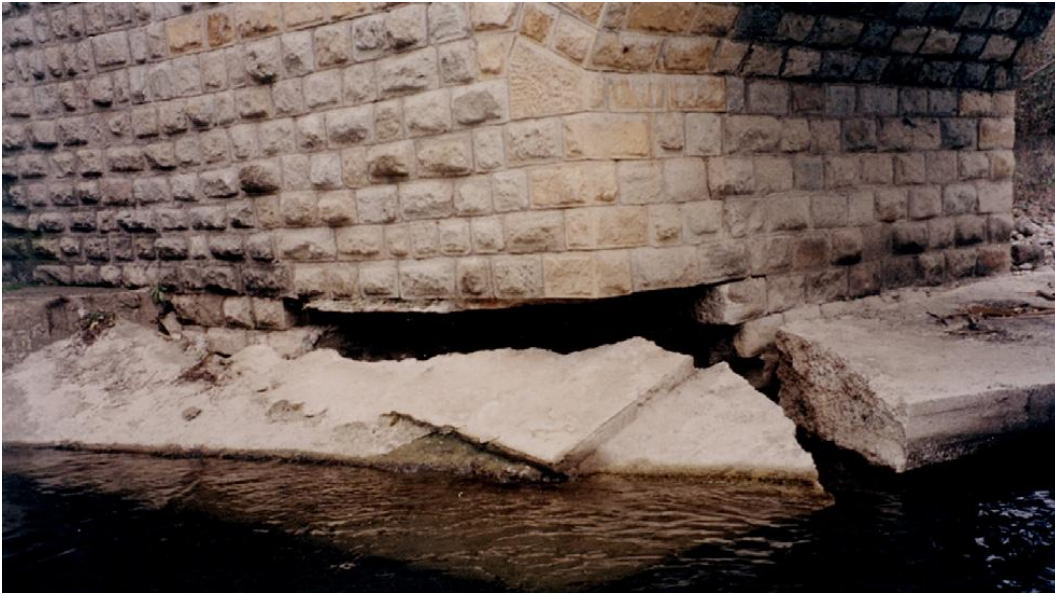
When piers or abutments settle, typically large cracks will occur on the span of the arch and movements throughout the structure. Settlements and the causes of settlements are often dramatic and can be seen upon visual inspection. Some reasons for damages due to support settlements include:

Figure 4.1: Example of failure from support settlement on Mataraci Bridge in Turkey (Ural, 2007).

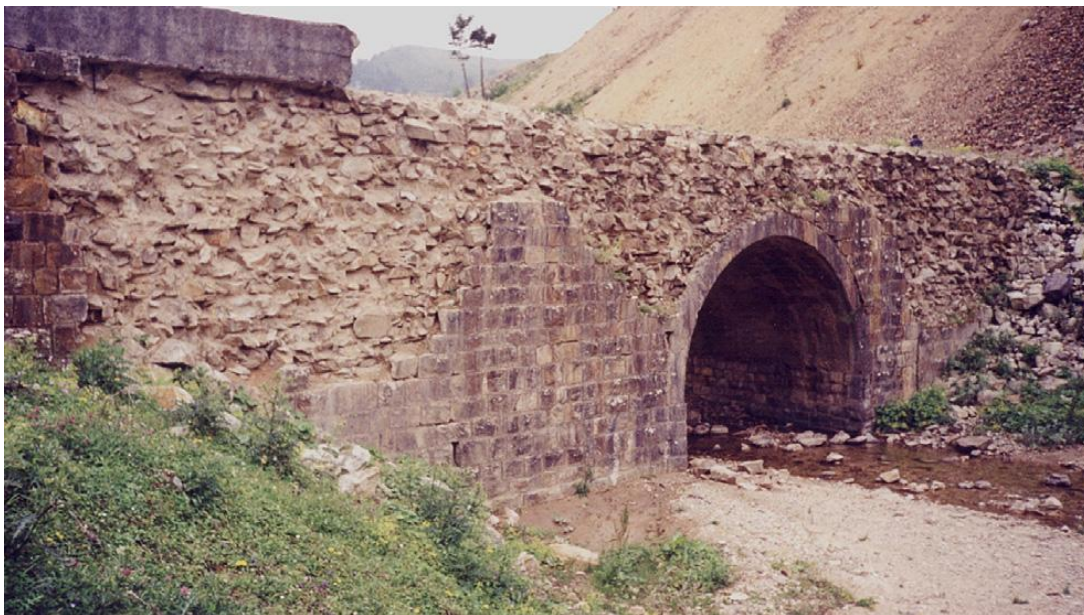
If masonry materials have poor performance against environmental conditions, they will deteriorate and cause damages to the bridge. These damages usually take place over a prolonged period of time. Deterioration may also be induced by loading affects, such as crushing. Weak masonry can lead to cracking, settlements, movements or even the development of hinges.

Figure 4.3: Deterioration of masonry material (Ural, 2007).

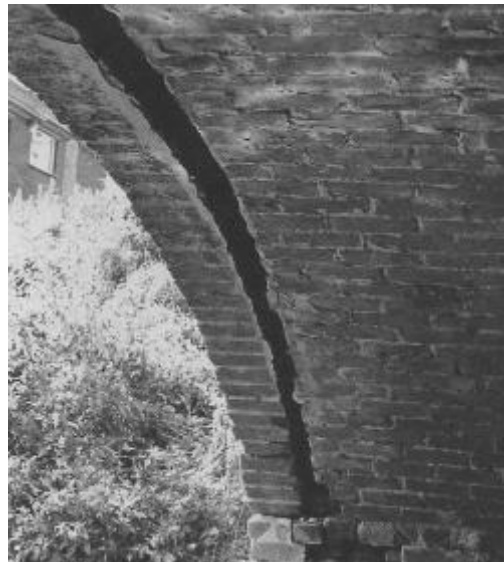
Spandrel walls stiffen the arch ring at its edges. Flexing of the arch ring due to traffic loads and outward movements of the spandrel will produce shear stresses between the outer edge of the ring which is stiffened by the above spandrel wall and the barrel which only contains flexible fill above it. Figure 4.4 shows a severe example of the cracking and separation that can occur. When the bridge contains stone spandrel walls and external voussoirs with the remaining arch made of brick, this is particularly vulnerable to such failure. Water may lend assistance to this type of damage if it penetrates to the spandrel wall and arch interface and deteriorates the mortar. Outward forces on the spandrel wall due to the fill may lend further assistance.

Figure 4.4: Longitudinal crack in arch ring (Page, 1996).

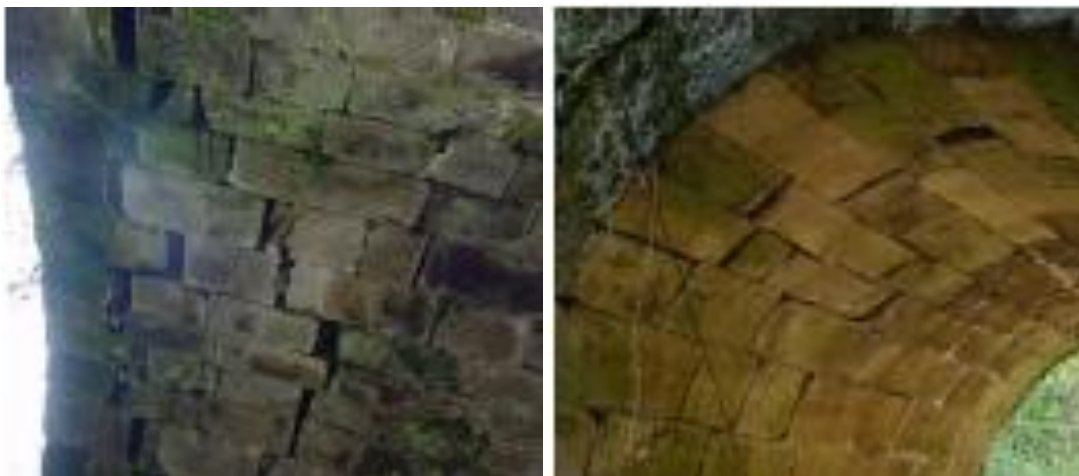
Abutments can be subjected to forces that move them outwards or inwards; the arch generates outward horizontal thrust and the fill behind abutments generate inward forces. The effects of movements on the arch depend on which direction it moves and whether there is rotation of the abutments. Transverse cracks in the arch ring are likely to manifest. If only one end of the abutment settles, longitudinal cracks are probable (Figure 4.5). This can become particularly serious if the arch ring is divided into independent segments by the cracks. Diagonal cracks may occur when one abutment tilts relative to the adjacent one. The crack will typically start at a springing near one side of the arch and propagate towards the center of the crown.

Figure 4.5: Longitudinal cracking (Oliveira, 2004)

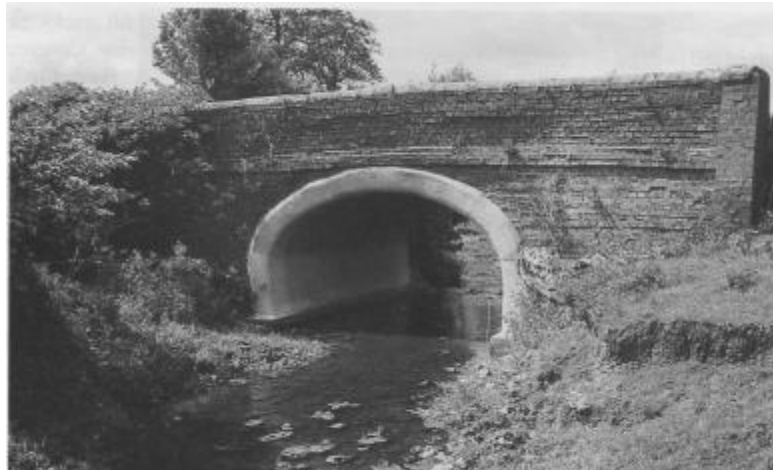
Figure 6.9: Sprayed concrete applied to face of arch ring. (Page, 1996)

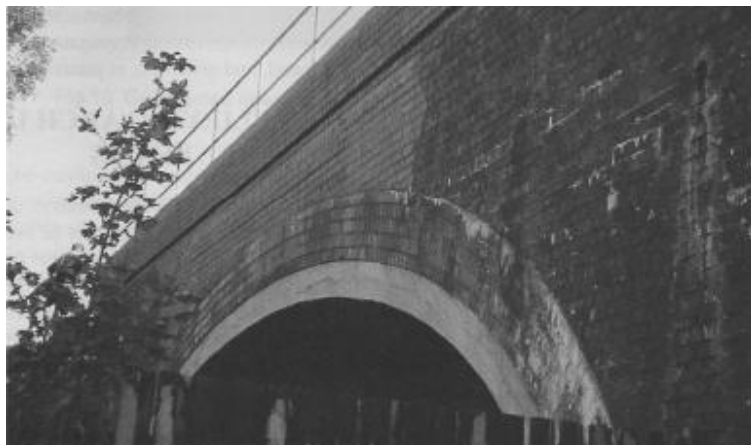
Figure 6.10: Sprayed concrete set in from edge of arch ring. (Page, 1996)

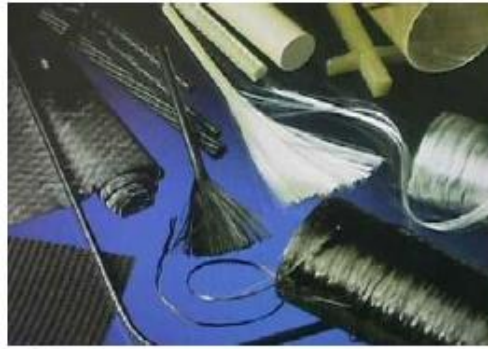
Figure 6.16: Types of FRP material (Pellegrino, 2009).

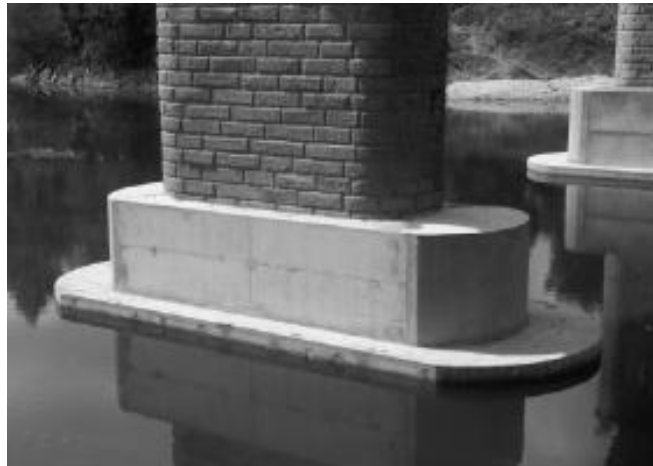
Figure 6.29: Concrete pile cap.

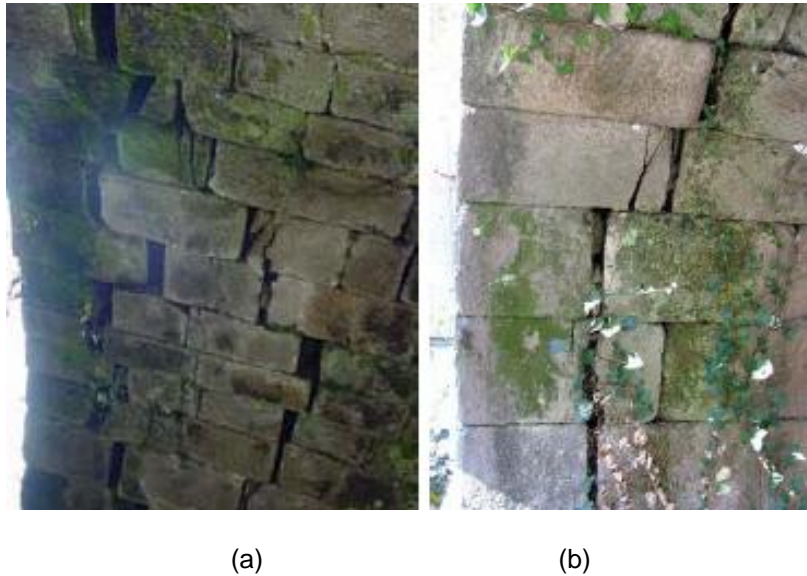
Figure 7.9: Longitudinal cracking in (a) arch A1 and (b) arch A4. (Apreutesei, 2005)

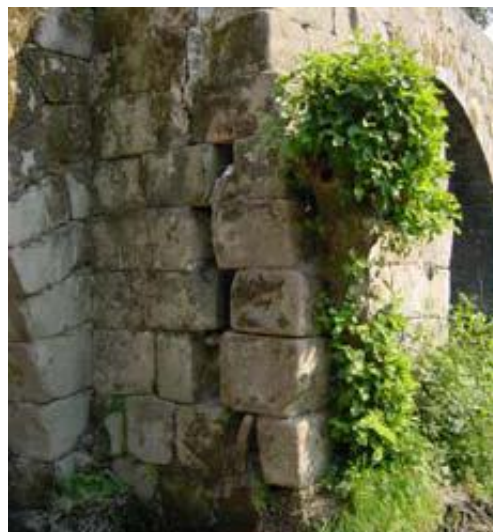
Figure 7.10: Cracks and vegetation in the right cutwater. (Oliveira, 2004)

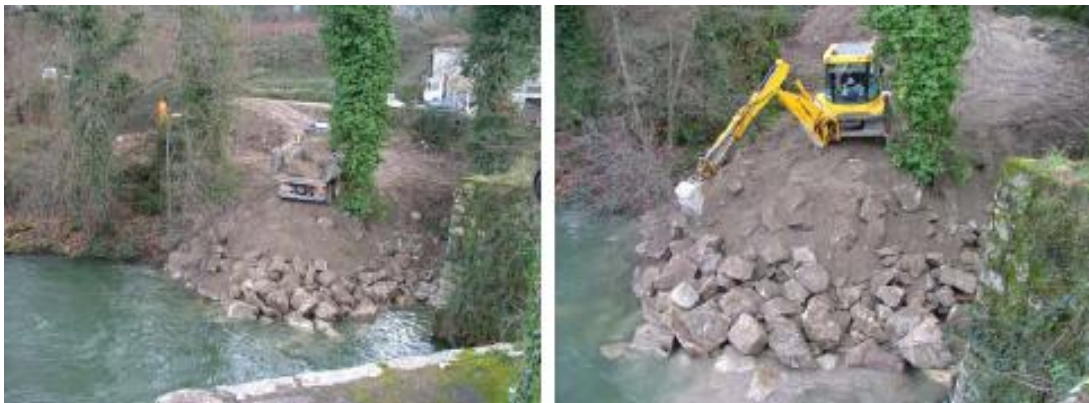
Figure 7.11: Blocking water flow. (Apreutesei, 2005)

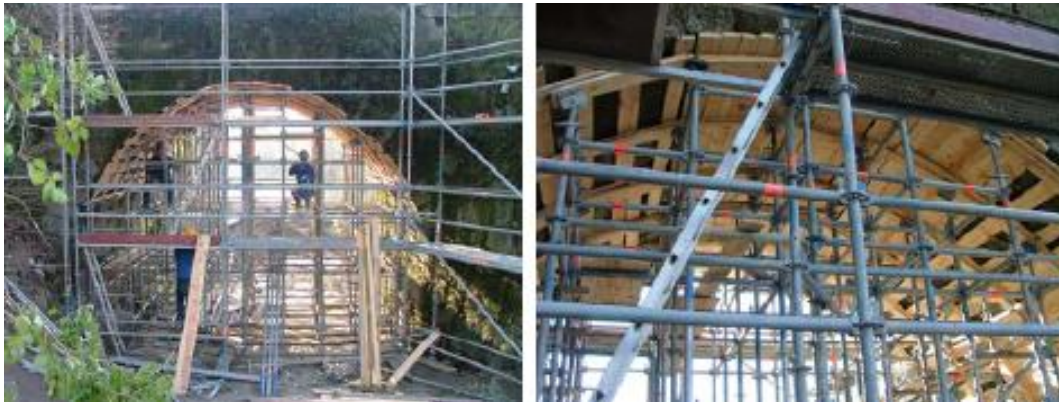
Figure 7.12: Temporary formwork. (Apreutesei, 2005)

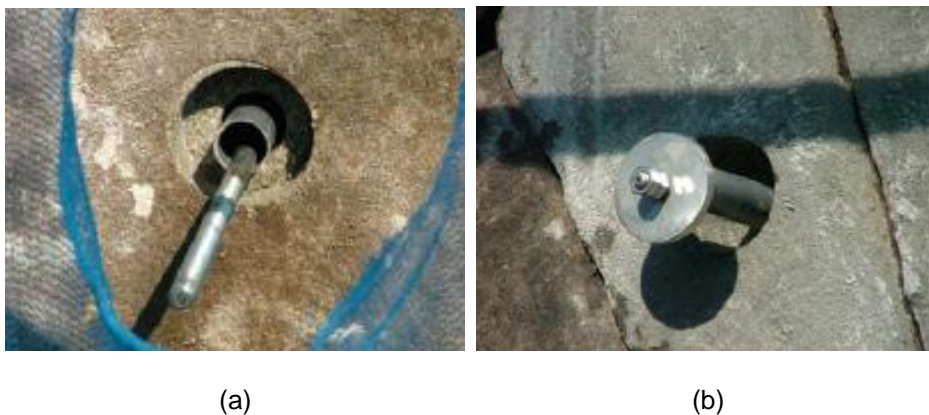
Figure 7.15: (a) Drilled hole with sleeve and rod in place; (b) Rod with anchorage plate. (Apreutesei, 2005)

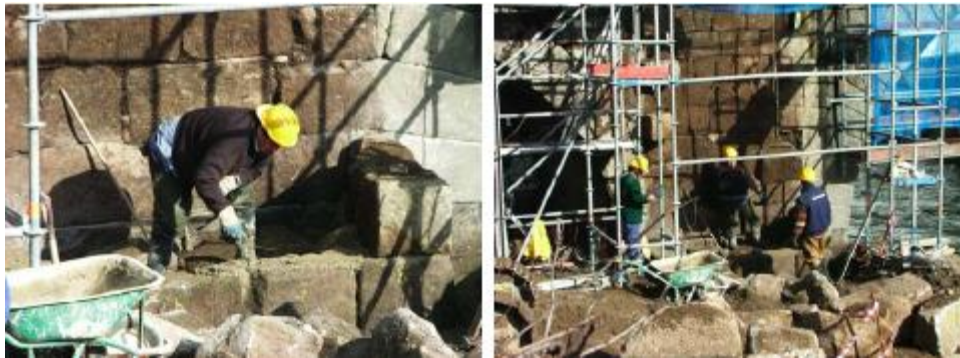
Figure 7.16: Rebuilding the right cutwater. (Apreutesei, 2005)

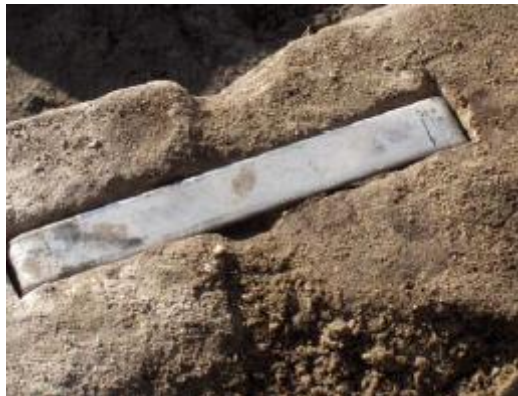
Figure 7.17: Stainless steel cramps. (Apreutesei, 2005)

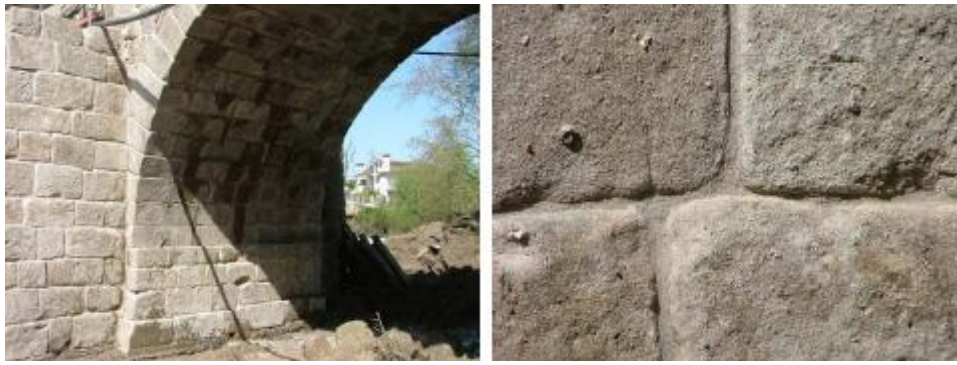
Figure 7.18: Repointed joints. (Apreutesei, 2005)
